**State of California  
The Resources Agency  
DEPARTMENT OF WATER RESOURCES  
DIVISION OF FLOOD MANAGEMENT**

**2004  
PROJECT STRUCTURE REPORT**

**INSPECTION OF  
FLOOD CONTROL STRUCTURES ON THE  
SACRAMENTO AND SAN JOAQUIN RIVERS  
AND THEIR TRIBUTARIES**

**Prepared By The  
Flood Operations Branch  
Flood Project Inspection Section**

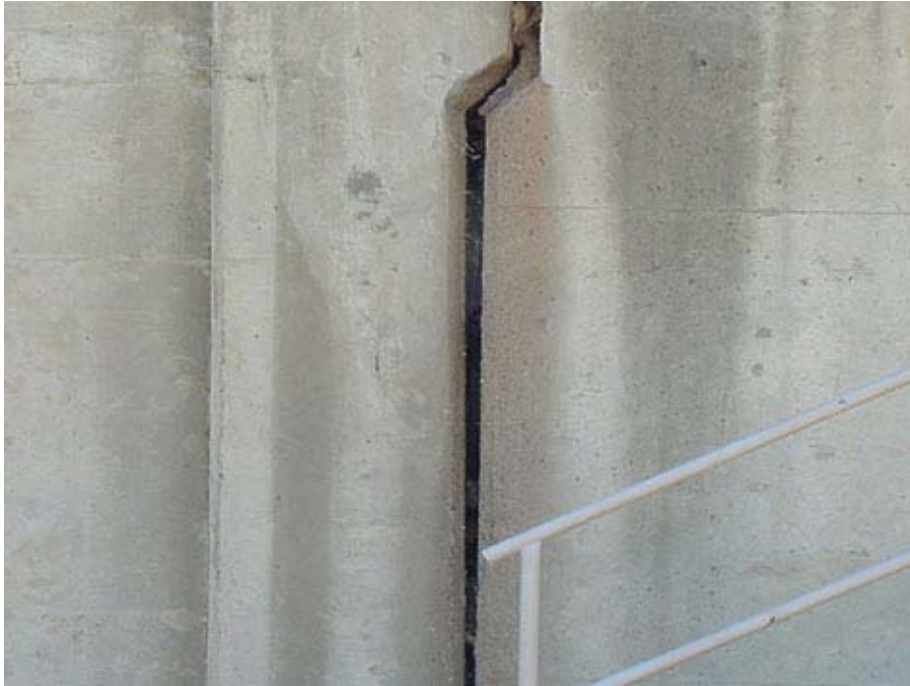
- 1. Condition of the main pump structure.**
  - a. Good.**
- 2. Condition of abutments and wing walls.**
  - a. There is a  $3\frac{5}{8}$  inch deflection in the retaining wall next to the stairway on the west side of structure.**

**Three and five eighth inch deflection in the west retaining wall.**

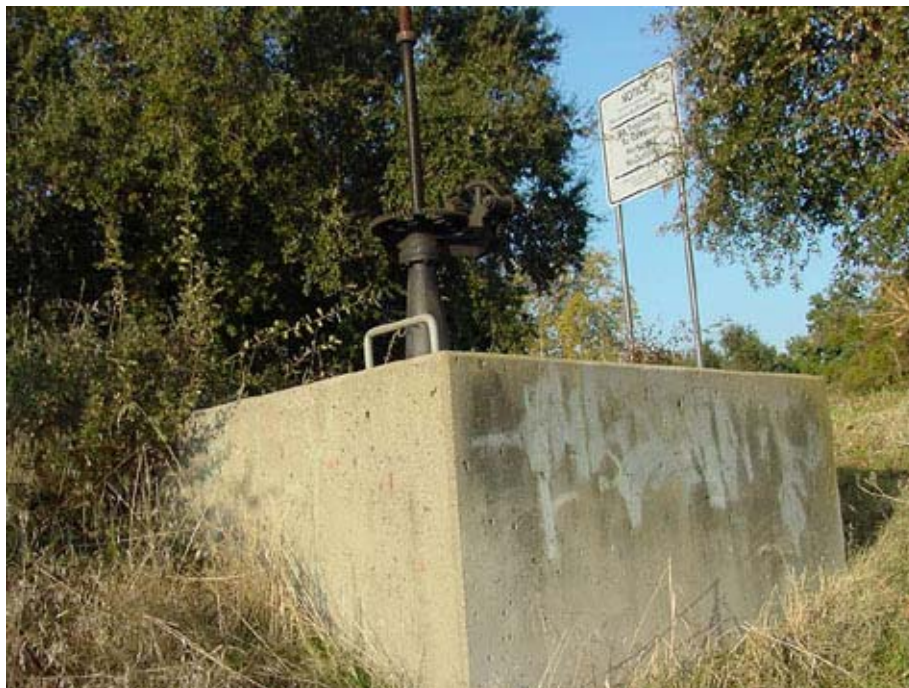
**View of the gate control mechanism box.**

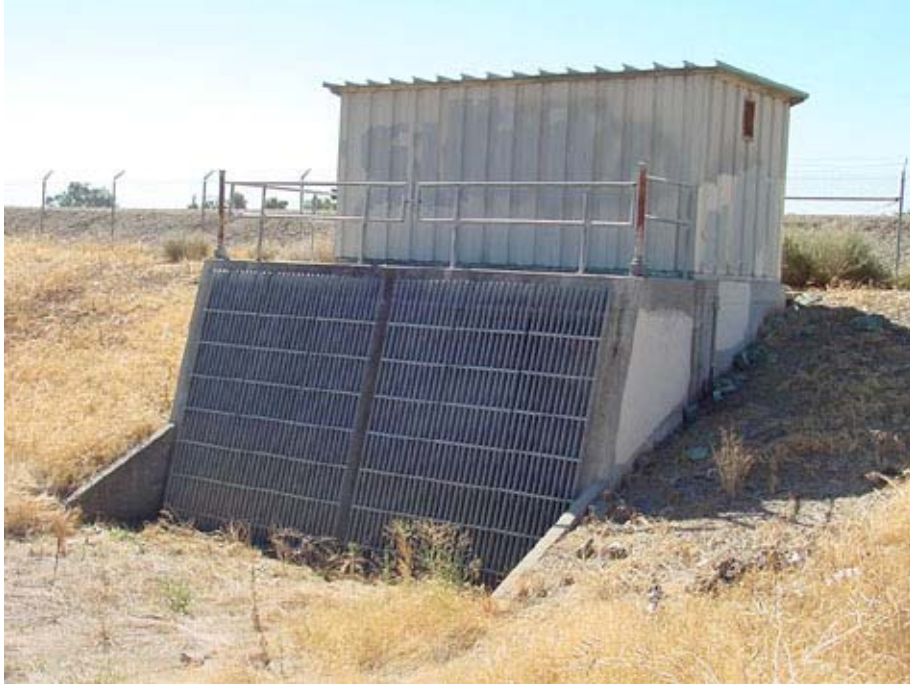
**The trash racks and the intake side of the pumping plant.**

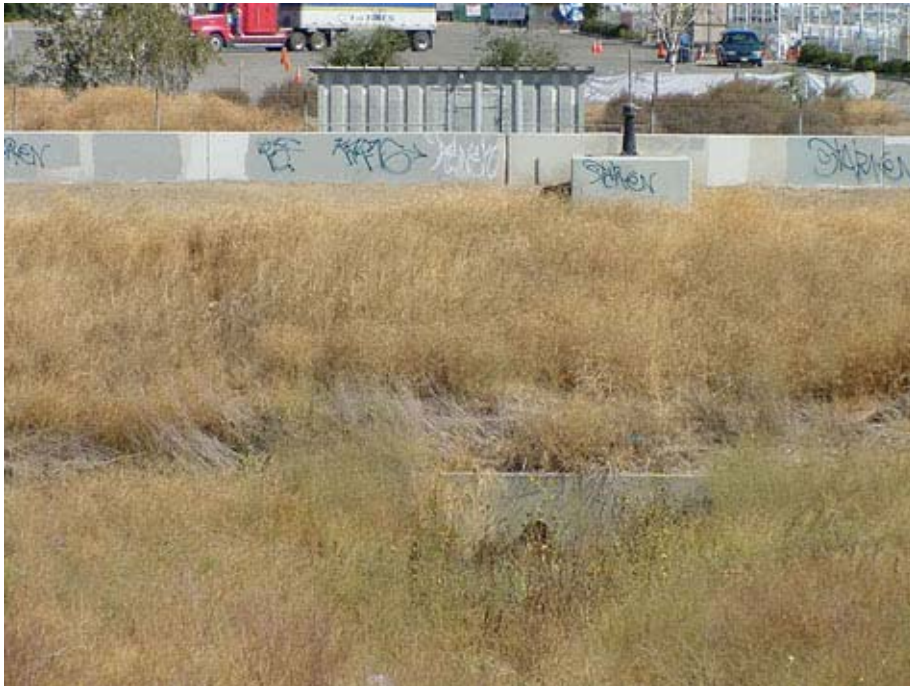
**The outlet for the pumping plant, screw gate and flood wall.**

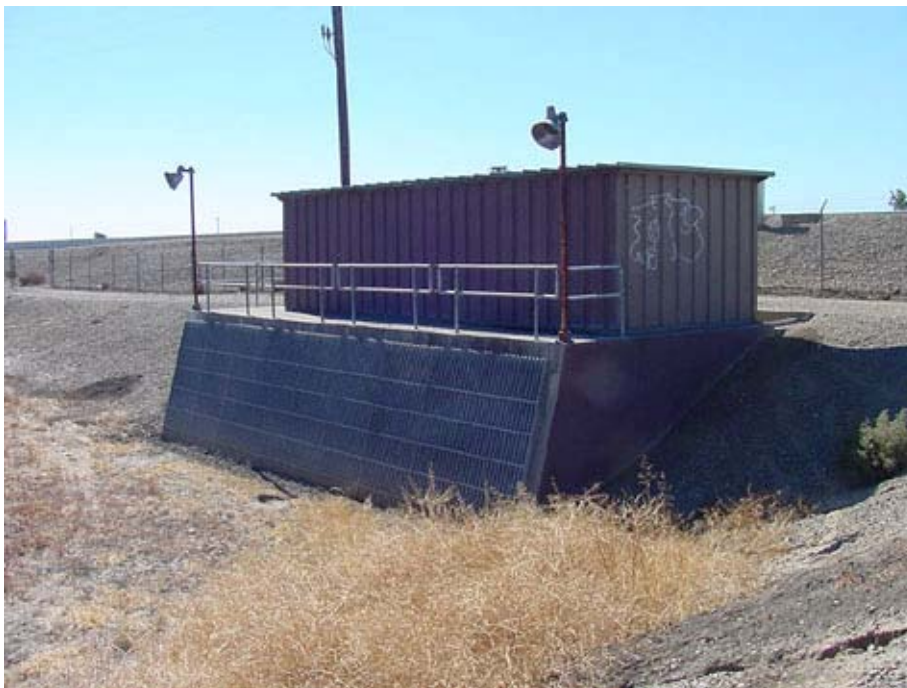
**The trash racks at the inlet side of the pumping plant.**

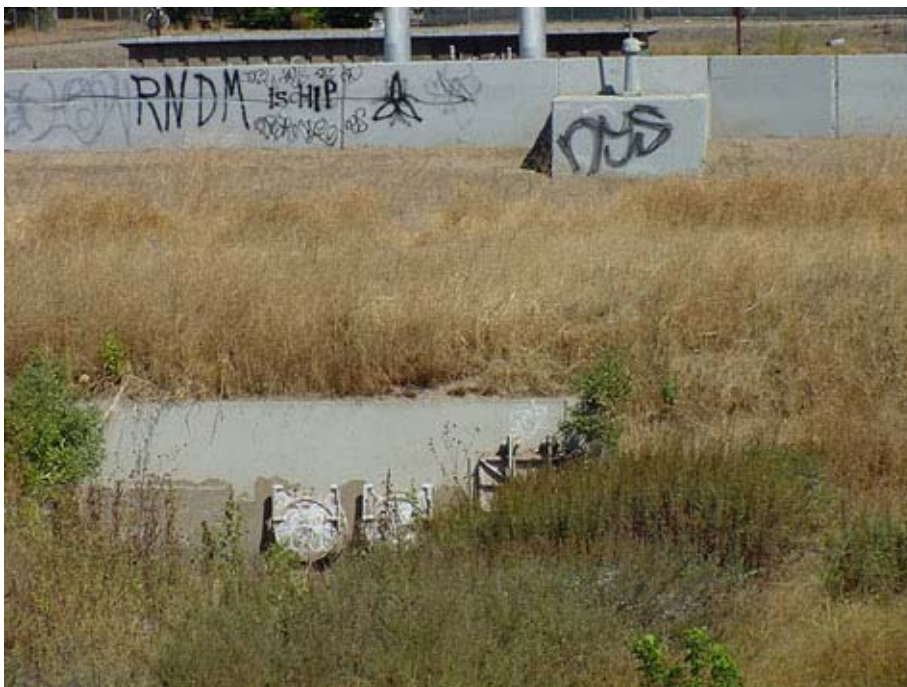
**The outlet for the pumping plant.**

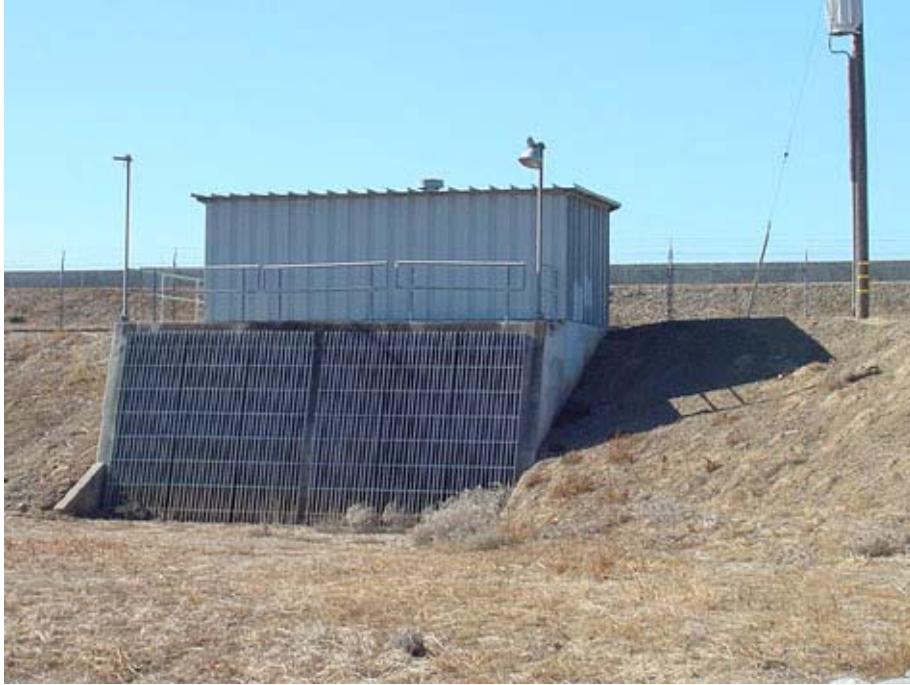
**The trash racks and the inlet side of the pumping plant.**

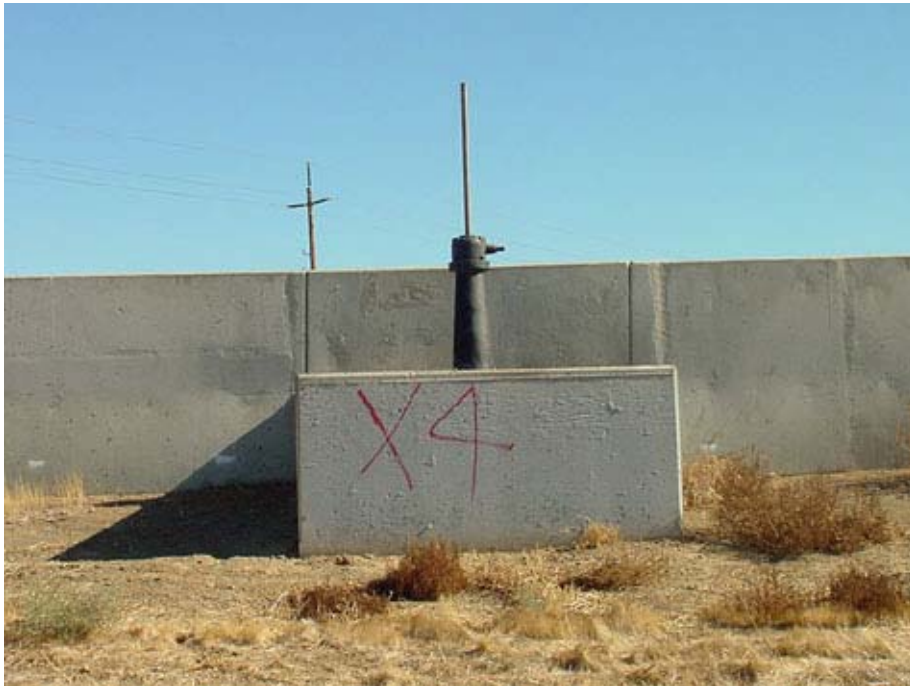
**The outlet side for the pumping plant, screw gate and flood wall.**

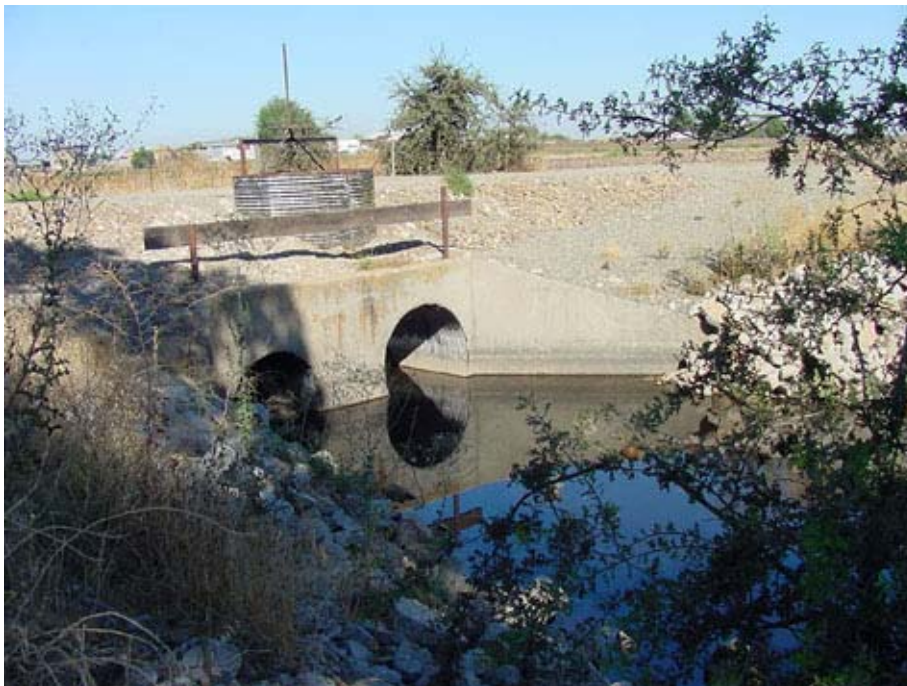
**The inlet side of the control structure.**

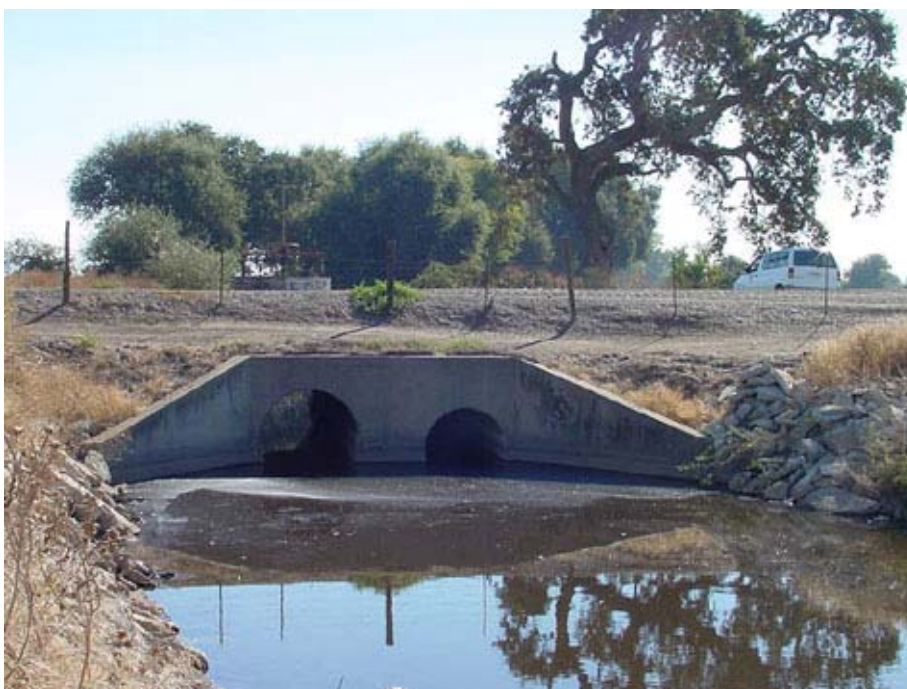
**The outlet side of the control structure.**

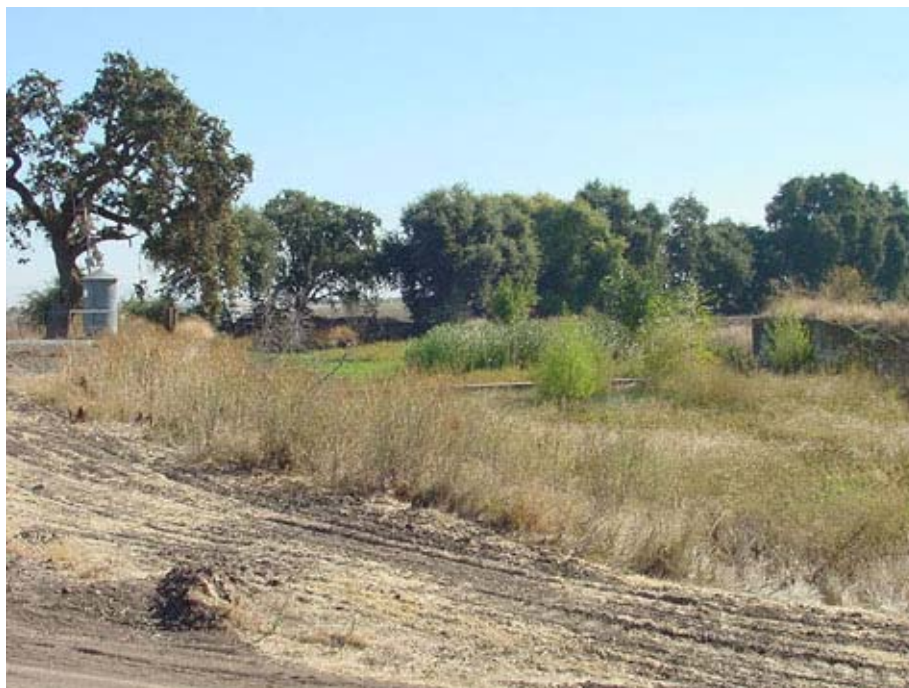
**Upstream at the diversion weir.**

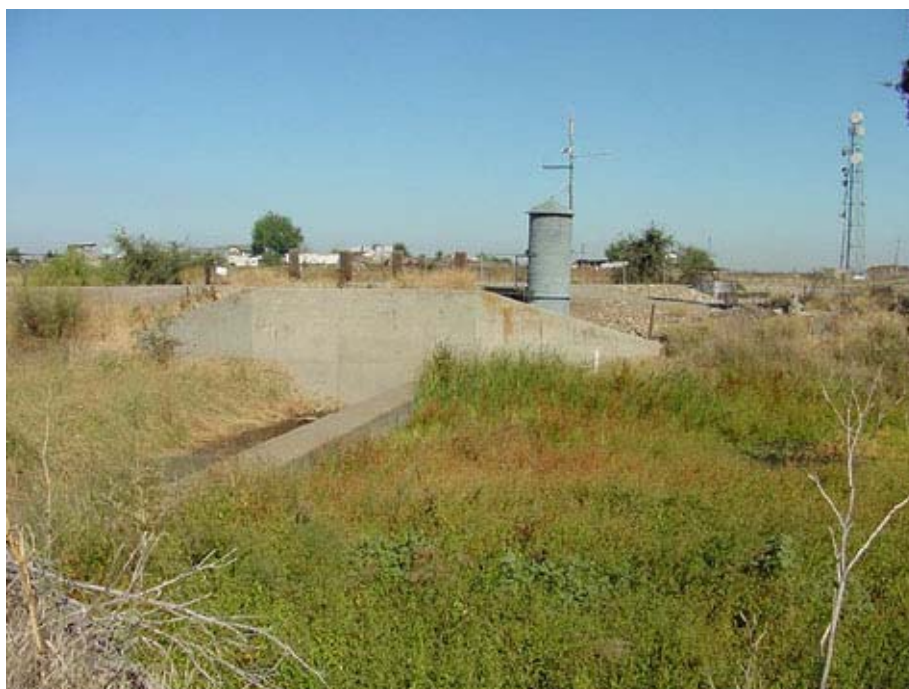
**The weir, stilling basin, right bank abutment and stream gauge.**

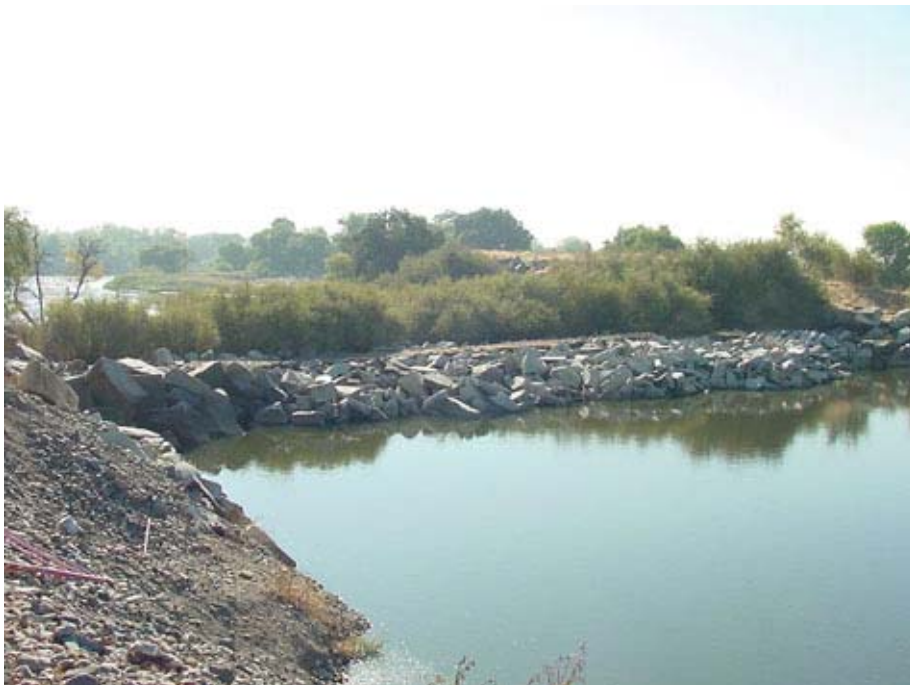
**The downstream side of dam.**

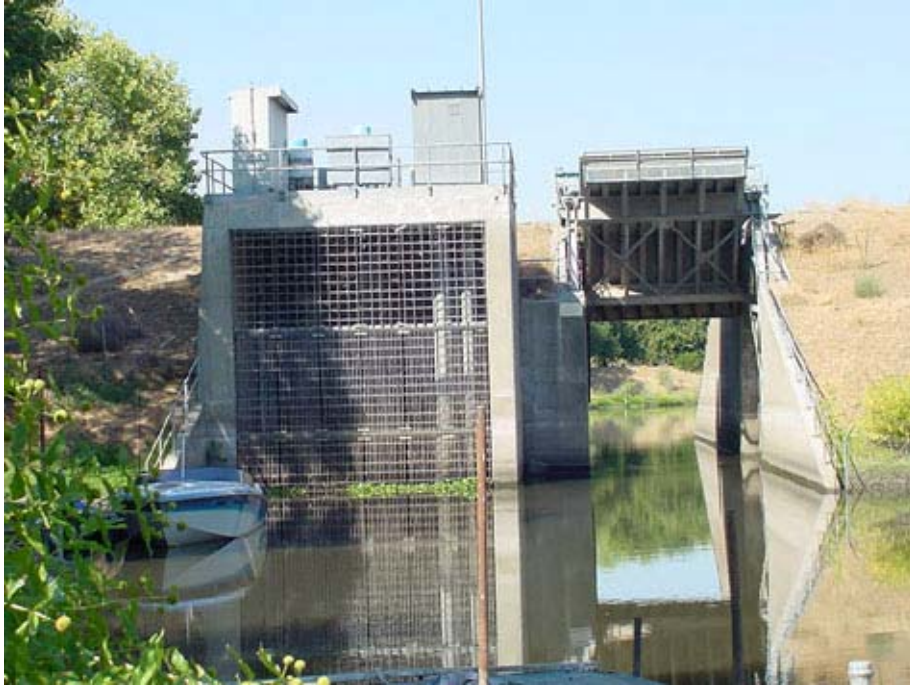
**The upstream side of the structure.**

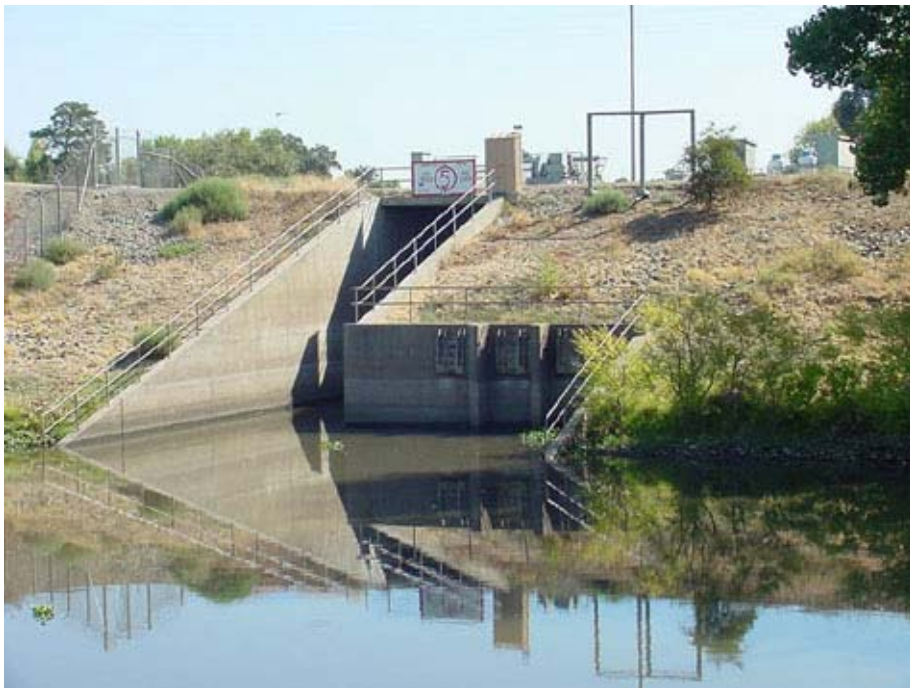
**The downstream side of the structure.**

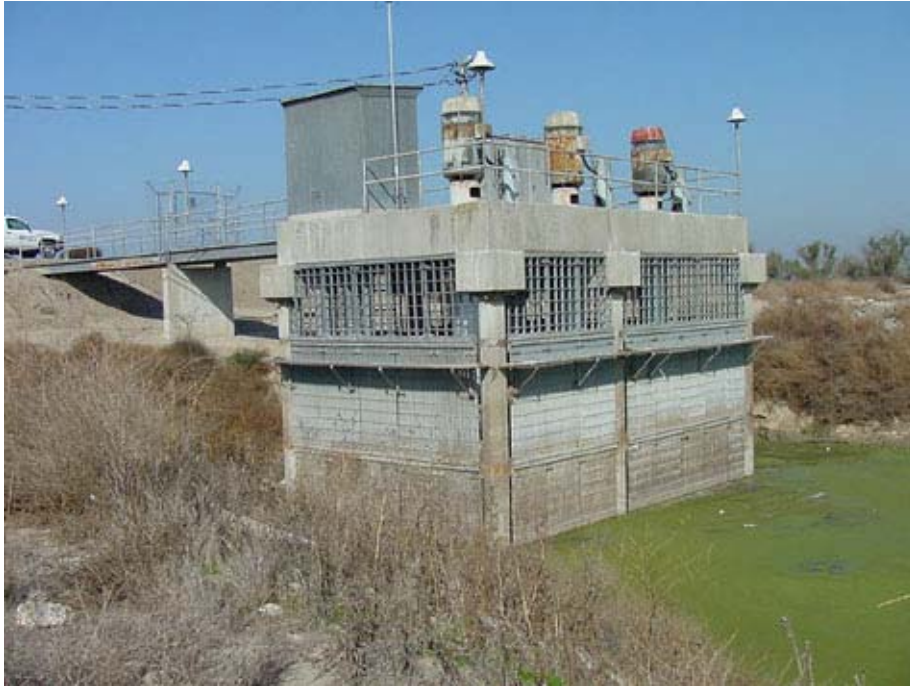
**The intake and pumps for the structure.**

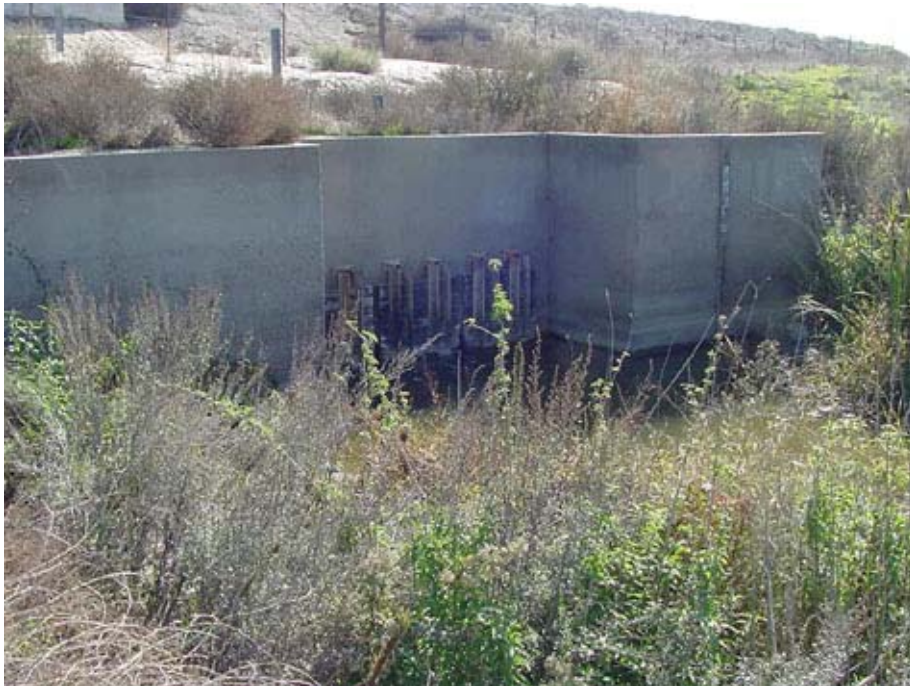
**The pumping plant outlet.**

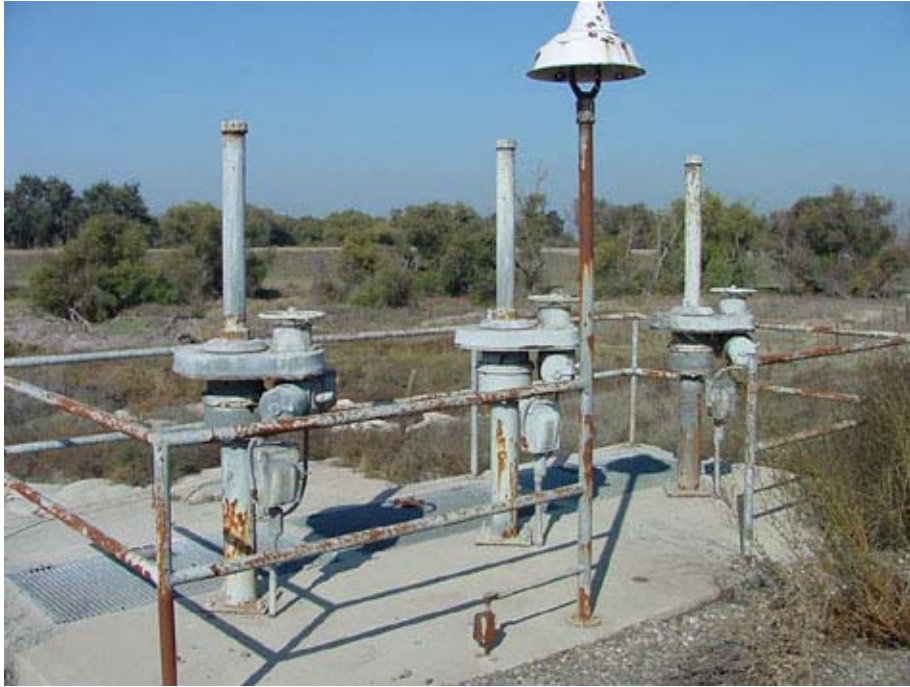
**The screw gates.**

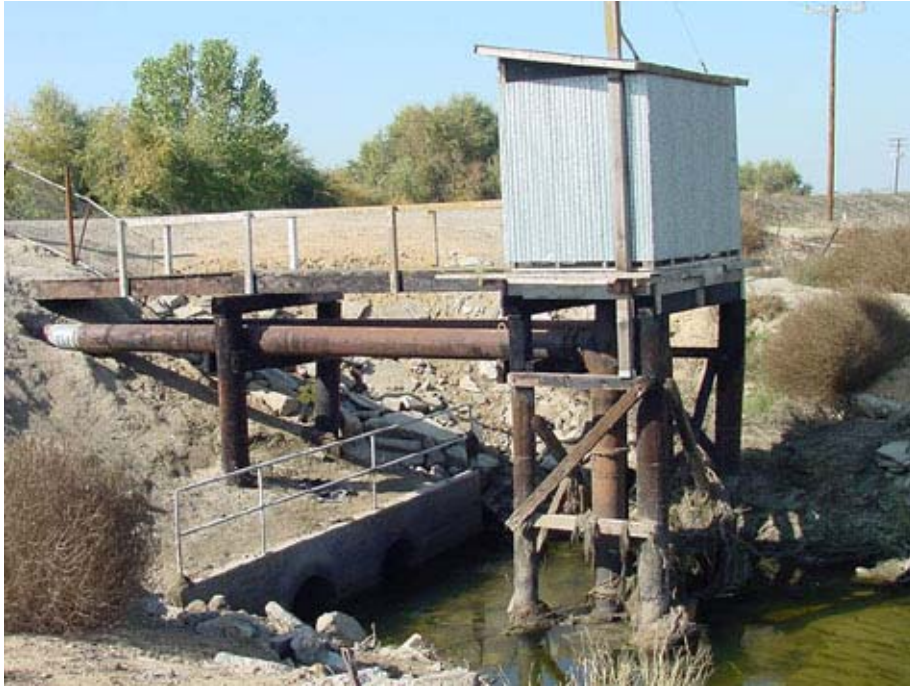
4. Condition of control gate, mechanism and flap gate.
  - a. Good.
5. Condition of the trash racks.
  - a. The trash racks were not present at the time of the inspection.

**The pumping plant intake.**

8. Comments:
  - a. The reclamation district is responsible for testing the pumps prior to flood season.
  - b. Replace the trash racks.
  - c. Monitor growth and remove as necessary.

- d. Poor maintenance.
  - e. The district should consider replacement or reconstruction of the pump house, platform and trash racks.
  - f. Numerous bullet holes in the pump house.

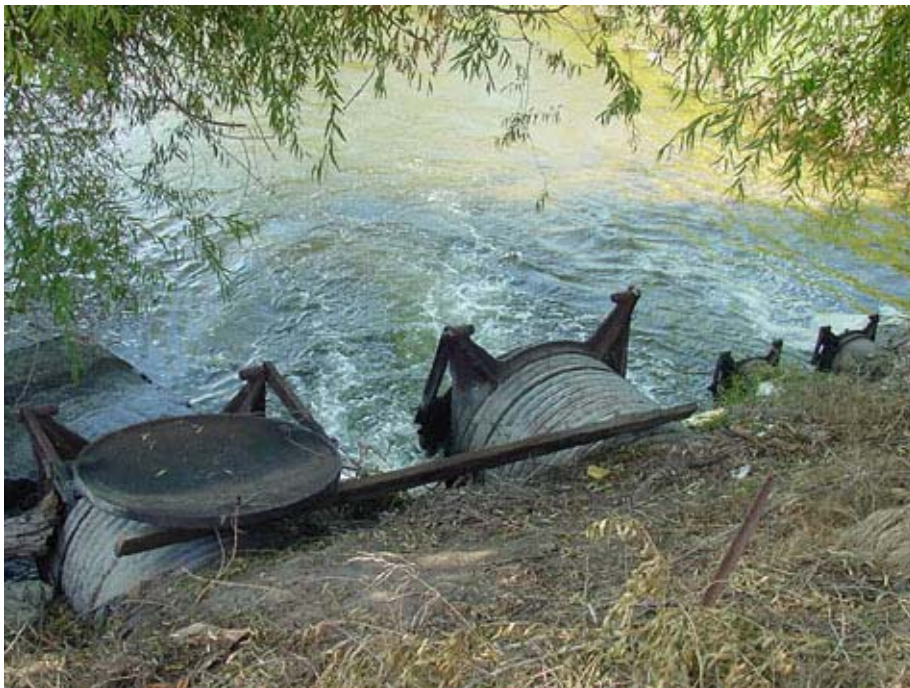
**The two discharge pipes.**

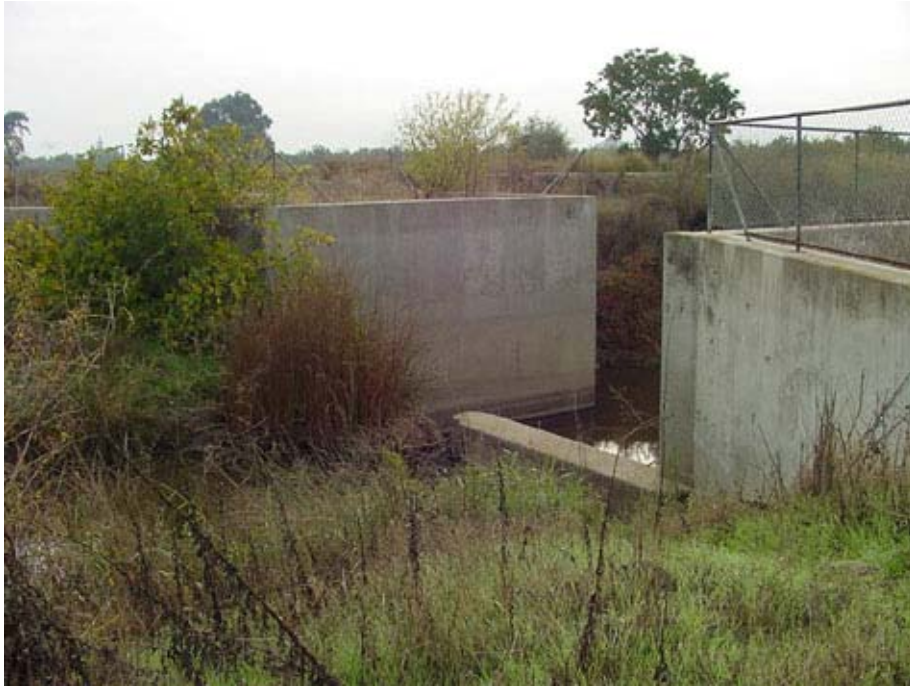
**The upstream side of the structure.**

- 1. Condition of concrete drop structure.**
  - a. Good.**
- 2. Condition of concrete abutments.**
  - a. Good.**
  - b. Separation of the left bank wall is stable.**
- 3. Condition of revetment.**
  - a. Good.**
- 4. Accumulation of trash and debris around the structure or in the channel.**
  - a. None.**
- 5. Vegetation around the structure or in the channel.**
  - a. A volunteer fig tree is in the channel upstream of the structure.**
- 6. Comments:**
  - a. Remove the fig tree.**
  - b. Remove growth upstream of the structure.**
  - c. Good maintenance.**

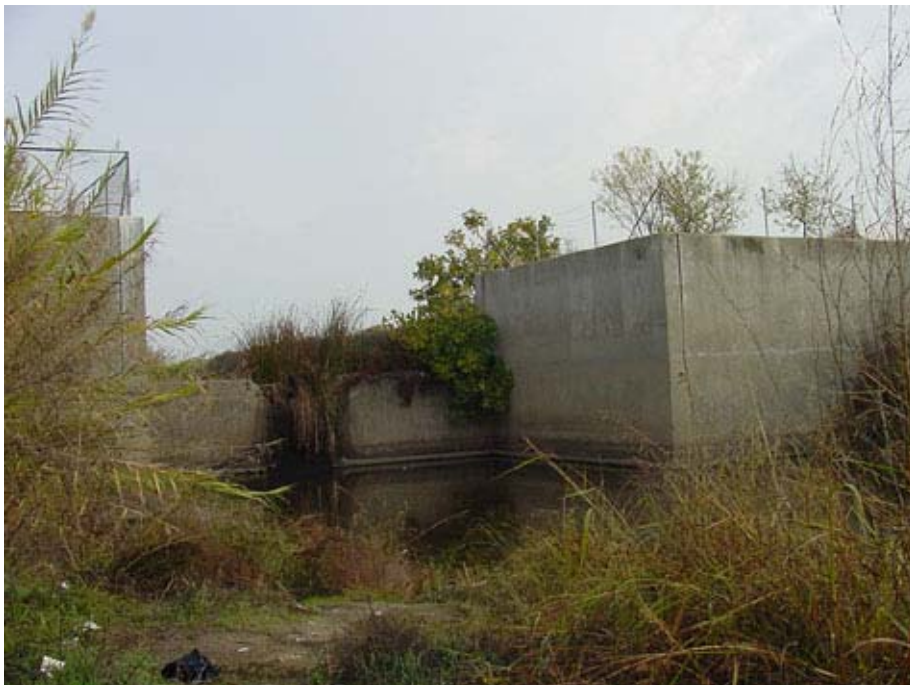
**The downstream side of the structure.**

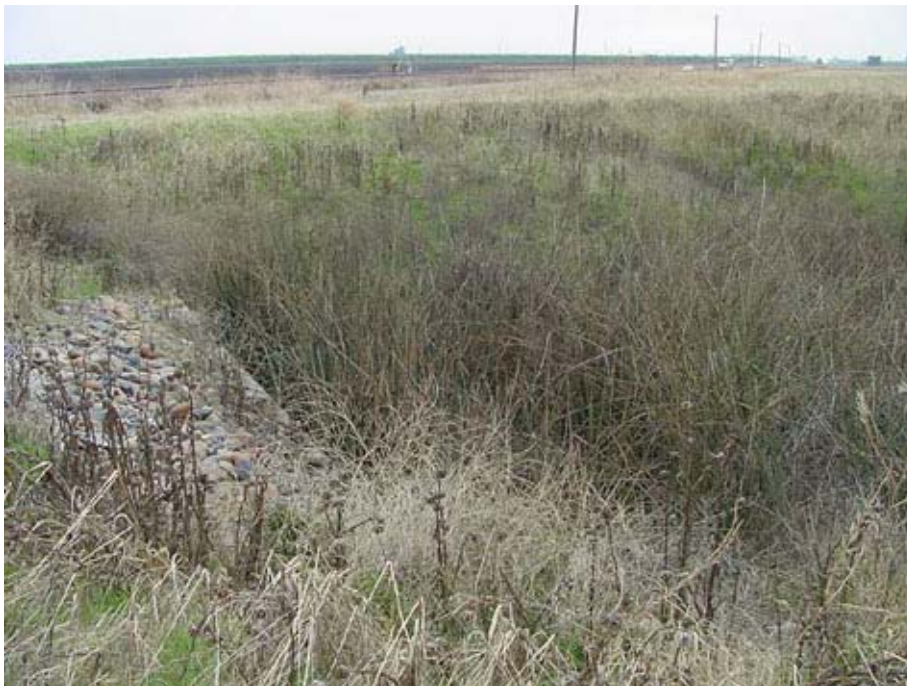
**The upstream side of the structure.**

- 1. Condition of concrete siphon structure.**
  - a. Good.**
- 2. Condition of concrete abutments and wing walls.**
  - a. Good.**
  - b. Separation of the left bank wall is stable.**
- 3. Condition of revetment.**
  - a. Good.**
- 4. Accumulation of trash and debris around the structure or in the channel.**
  - a. None.**
- 5. Vegetation around the structure or in the channel.**
  - a. There is dense tule and weed growth in the channel immediately upstream and downstream of the structure.**
- 6. Comments:**
  - a. Remove weeds and tule growth.**
  - b. Fair maintenance.**

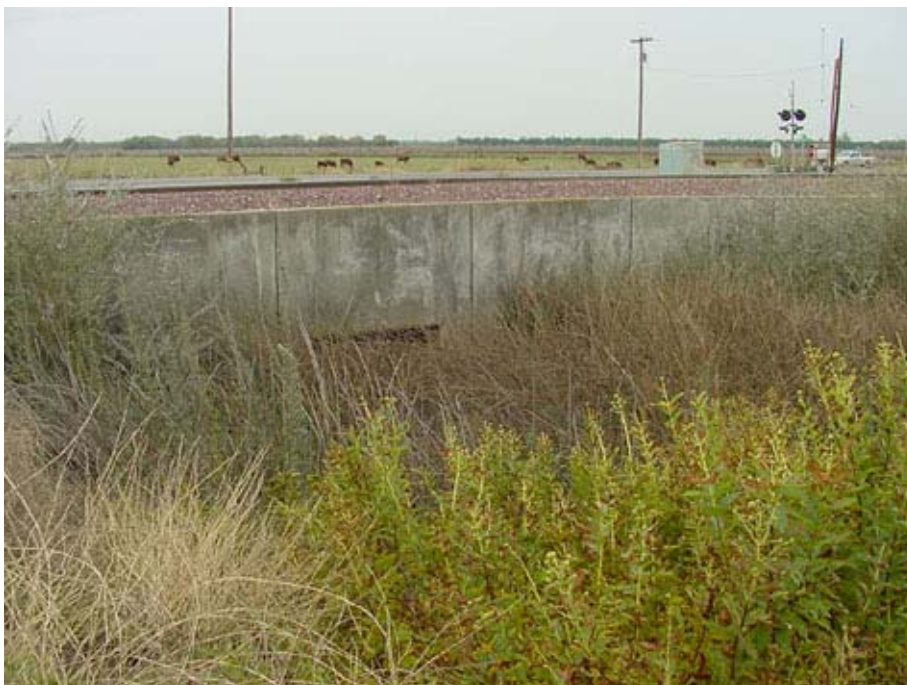
**The downstream side of the structure.**

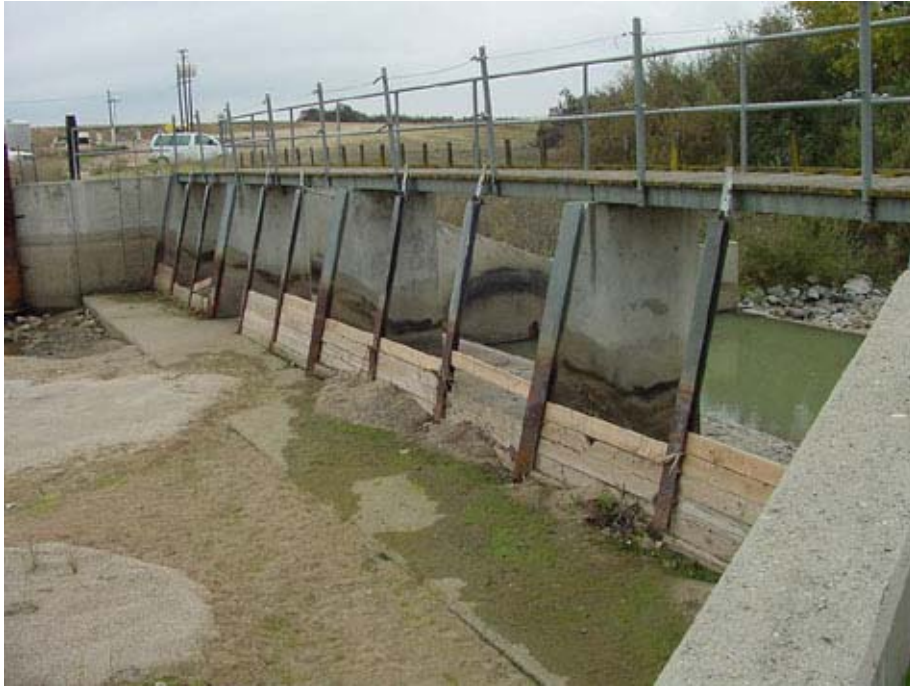
**The upstream side of the Berenda structure.**

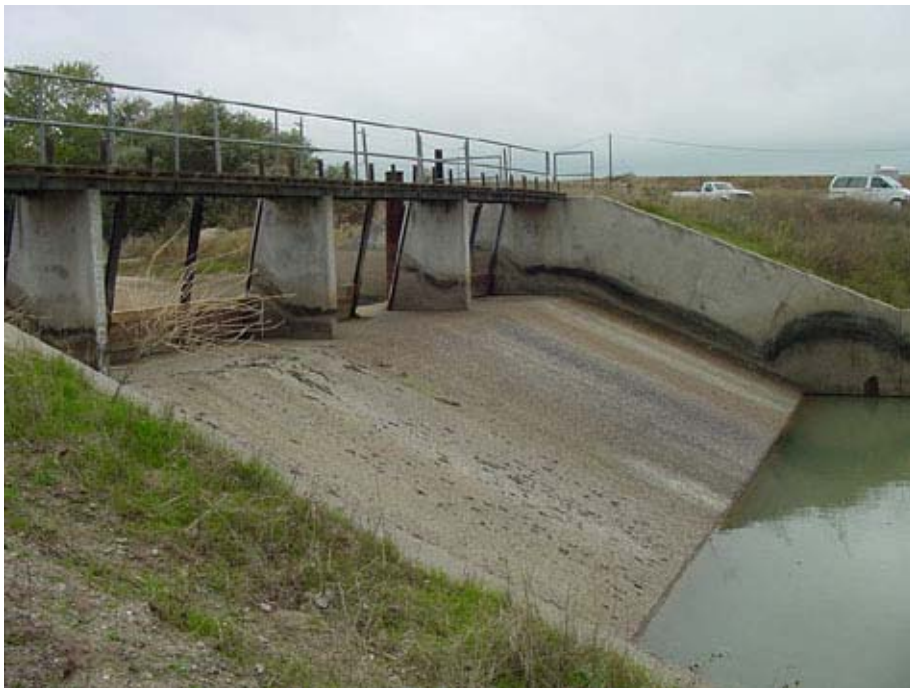
**The downstream side of the Berenda structure.**

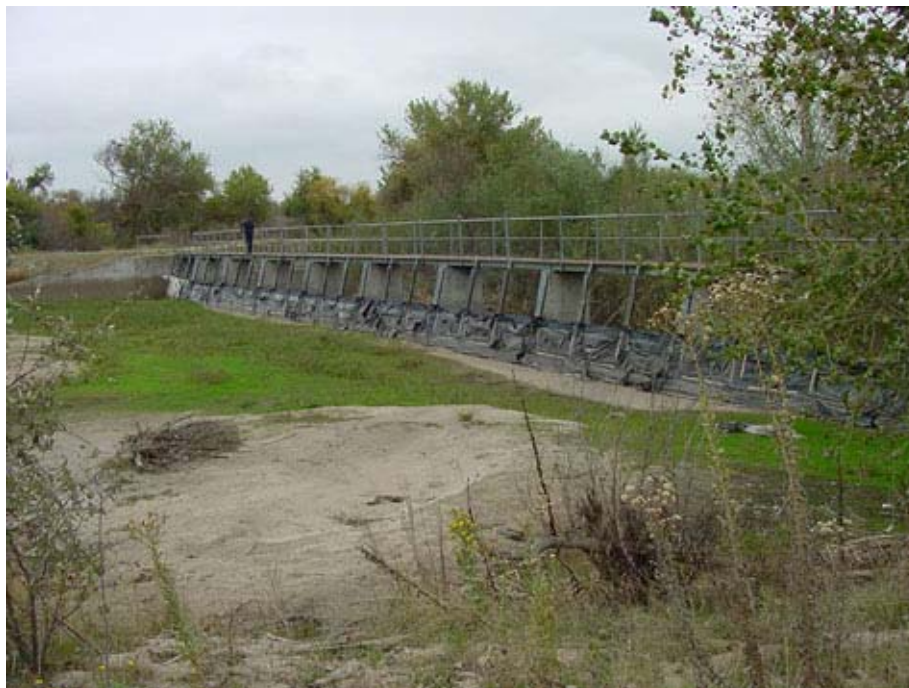
**The upstream side of the Ash structure.**

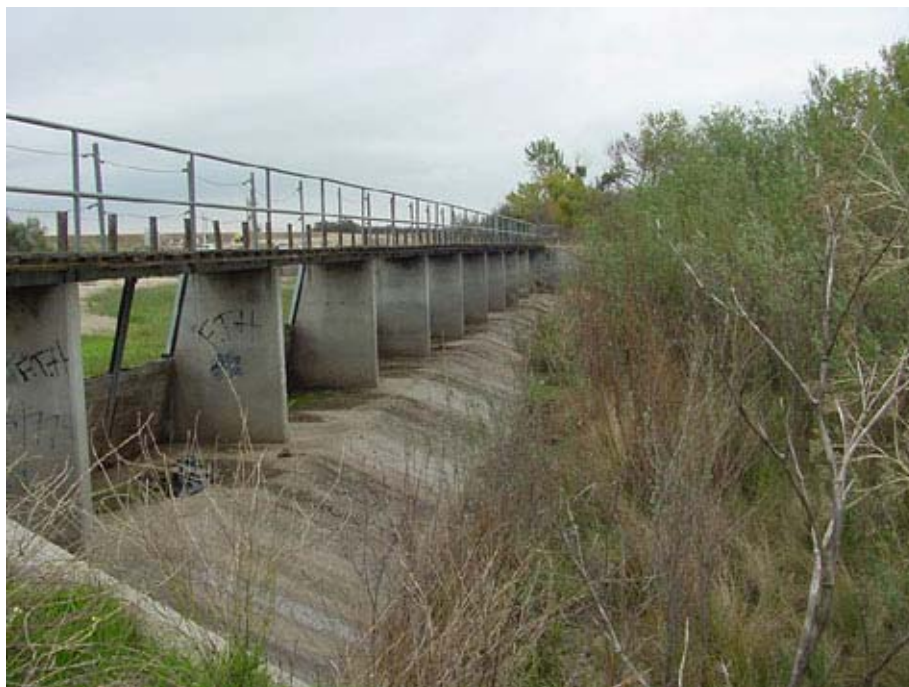
**The downstream side of the Ash structure.  
Note the dense vegetation.**

- 1. Condition of concrete control structures.**
  - a. Good.**
- 2. Condition of concrete abutments and wing walls.**
  - a. Good.**
- 3. Condition of stop logs and supports.**
  - a. Good.**
- 4. Condition of revetments.**
  - a. Good.**
- 5. Accumulation of trash and debris around the structures or in the channels.**
  - a. None.**
- 6. Vegetation around the control structures or in the channels.**
  - a. Dense vegetation in the channel downstream of the structure.**
- 7. Comments:**
  - a. Remove the vegetation from the channel and around the structure.**
  - b. Good maintenance.**
  - c. Cable on top of the structure needs to be repaired.**

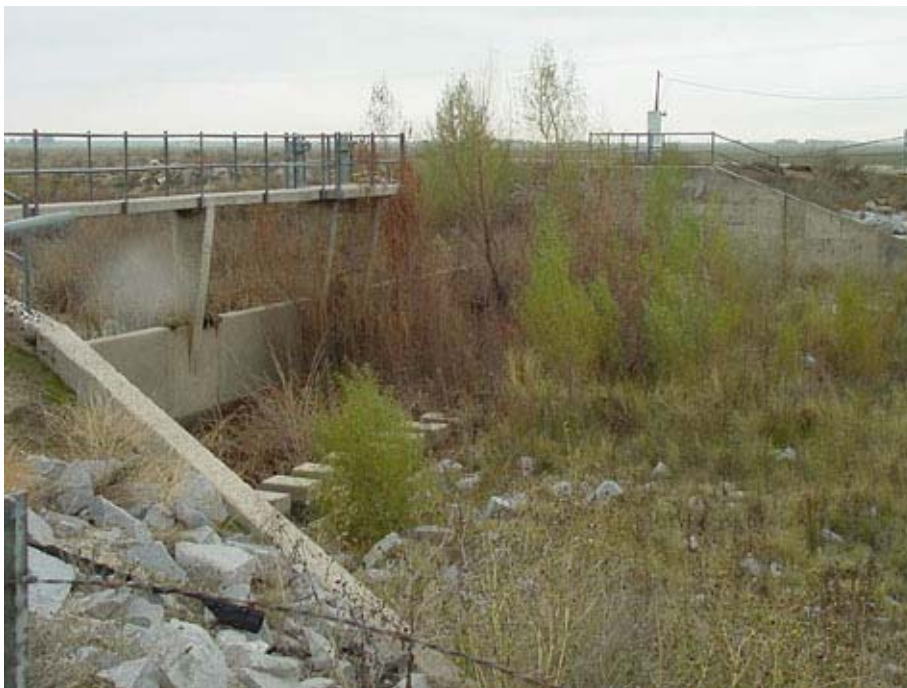
**The downstream side of the diversion weir.**

1. Condition of concrete weir structure, stilling basin, and velocity dissipaters.
  - a. Good.
2. Condition of the diversion structure.
  - a. Good.
3. Condition of the concrete abutments and wing walls.
  - a. Good.
4. Condition of control gate and mechanisms.
  - a. Good.
5. Condition of revetments.
  - a. Good.
6. Accumulation of trash and debris around the structures or in the channel.
  - a. None.
7. Vegetation around the structures or in the channel.
  - a. Moderate growth in channel and around the structure.
8. Condition of gauging house and equipment.
  - a. Good.
9. Comments:
  - a. Remove the growth from the structure and channel.
  - b. Fair maintenance.

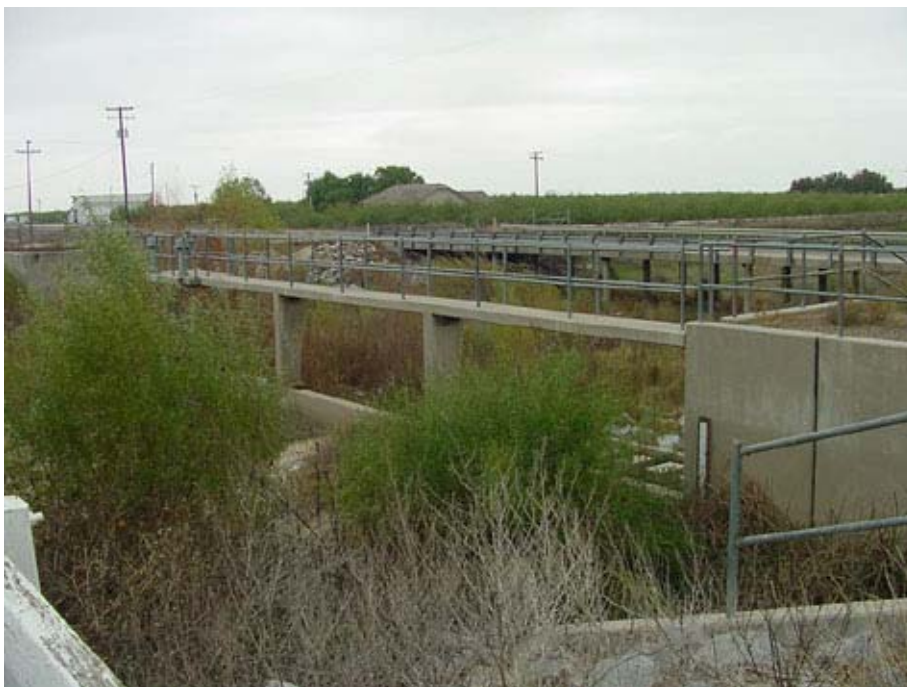
**The upstream side of the diversion weir.**

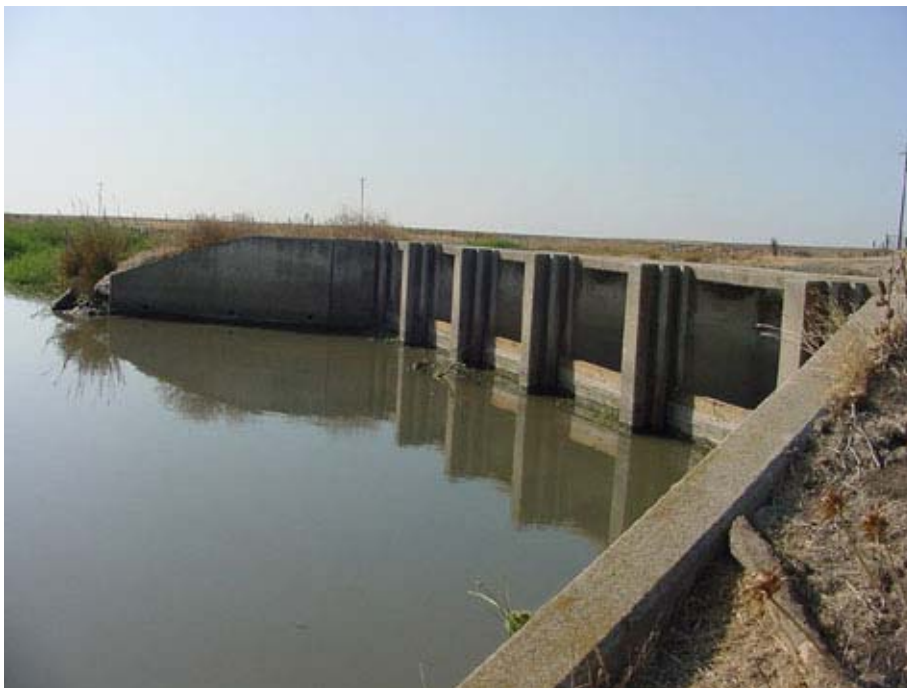
1. Condition of concrete weir structure and stilling basin.
  - a. Good.
2. Condition of concrete abutments and wing walls.
  - a. Good.
3. Condition of revetment.
  - a. Damage to both banks upstream of the structure.
4. Accumulation of trash and debris around the structure or in the channel.
  - a. None.
5. Vegetation around the structure or in the channel.
  - a. Moderate.
6. Comments:
  - a. Monitor and repair revetment as needed.
  - b. Remove vegetation.
  - c. Good maintenance.

**The upstream side of the structure.**

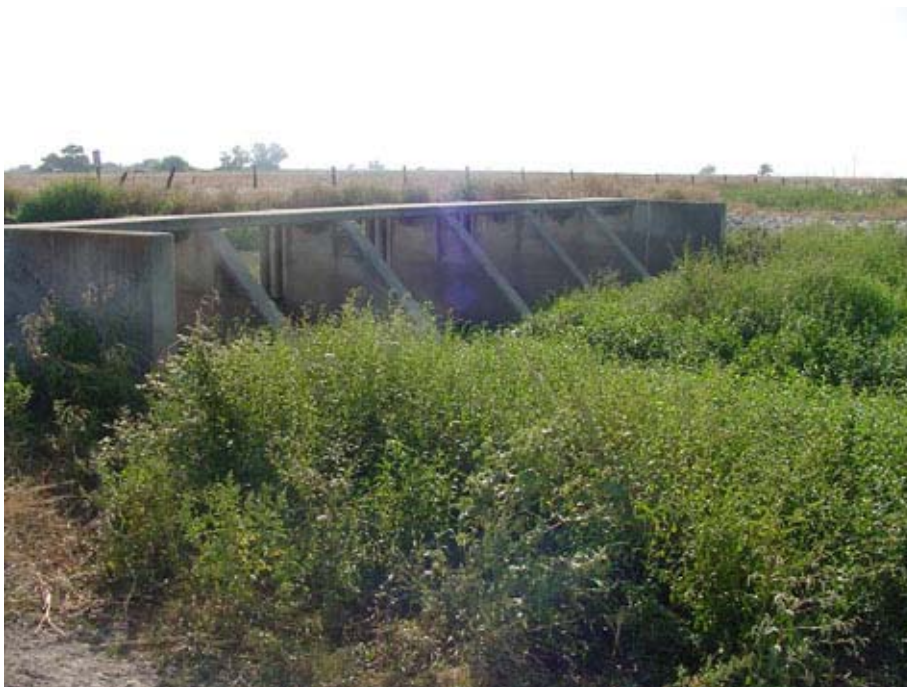
**The downstream side of the structure.**

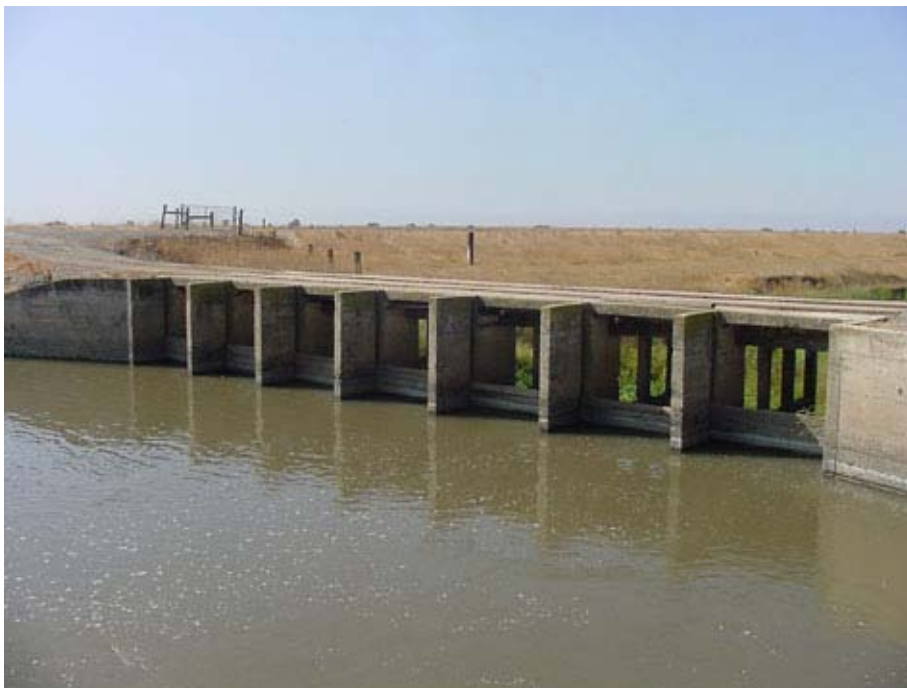
1. **Condition of concrete control structure.**
  - a. **Good.**
2. **Condition of abutments and wing walls.**
  - a. **There are 2 inch cracks, four to five feet in length in the right and left bank abutments.**
3. **Condition of stop logs and supports.**
  - a. **Good.**
4. **Accumulation of trash and debris around the structure or in the channel.**
  - a. **None.**
5. **Vegetation around the structure or in the channel.**
  - a. **Minimal.**
6. **Comments:**
  - a. **This structure was in existence prior to the construction of the project and is a part of the Lower San Joaquin Levee District but is operated by Eastside Canal Company.**
  - b. **Monitor and repair the cracks in the abutments as needed.**
  - c. **Fair maintenance.**
  - d. **Wooden bridge crossing has new timber, replaced by L.S.J.L.D.**

**The upstream side of the structure.**

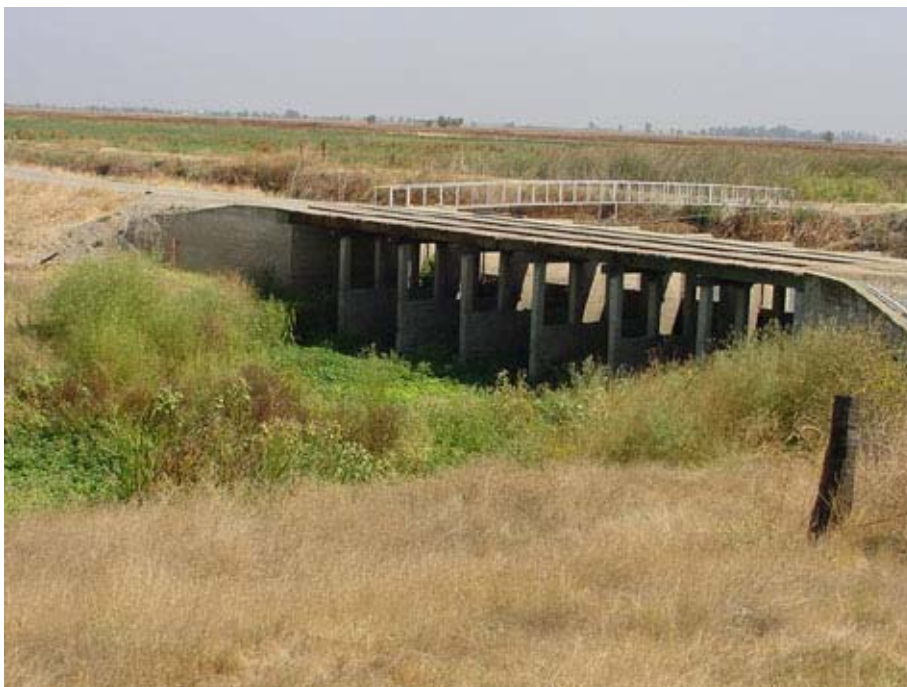
**The downstream side of the structure.**
